NASA TM X-64754

VAMISTOR RESISTOR INVESTIGATION

Quality and Reliability Assurance Laboratory

May 1, 1973

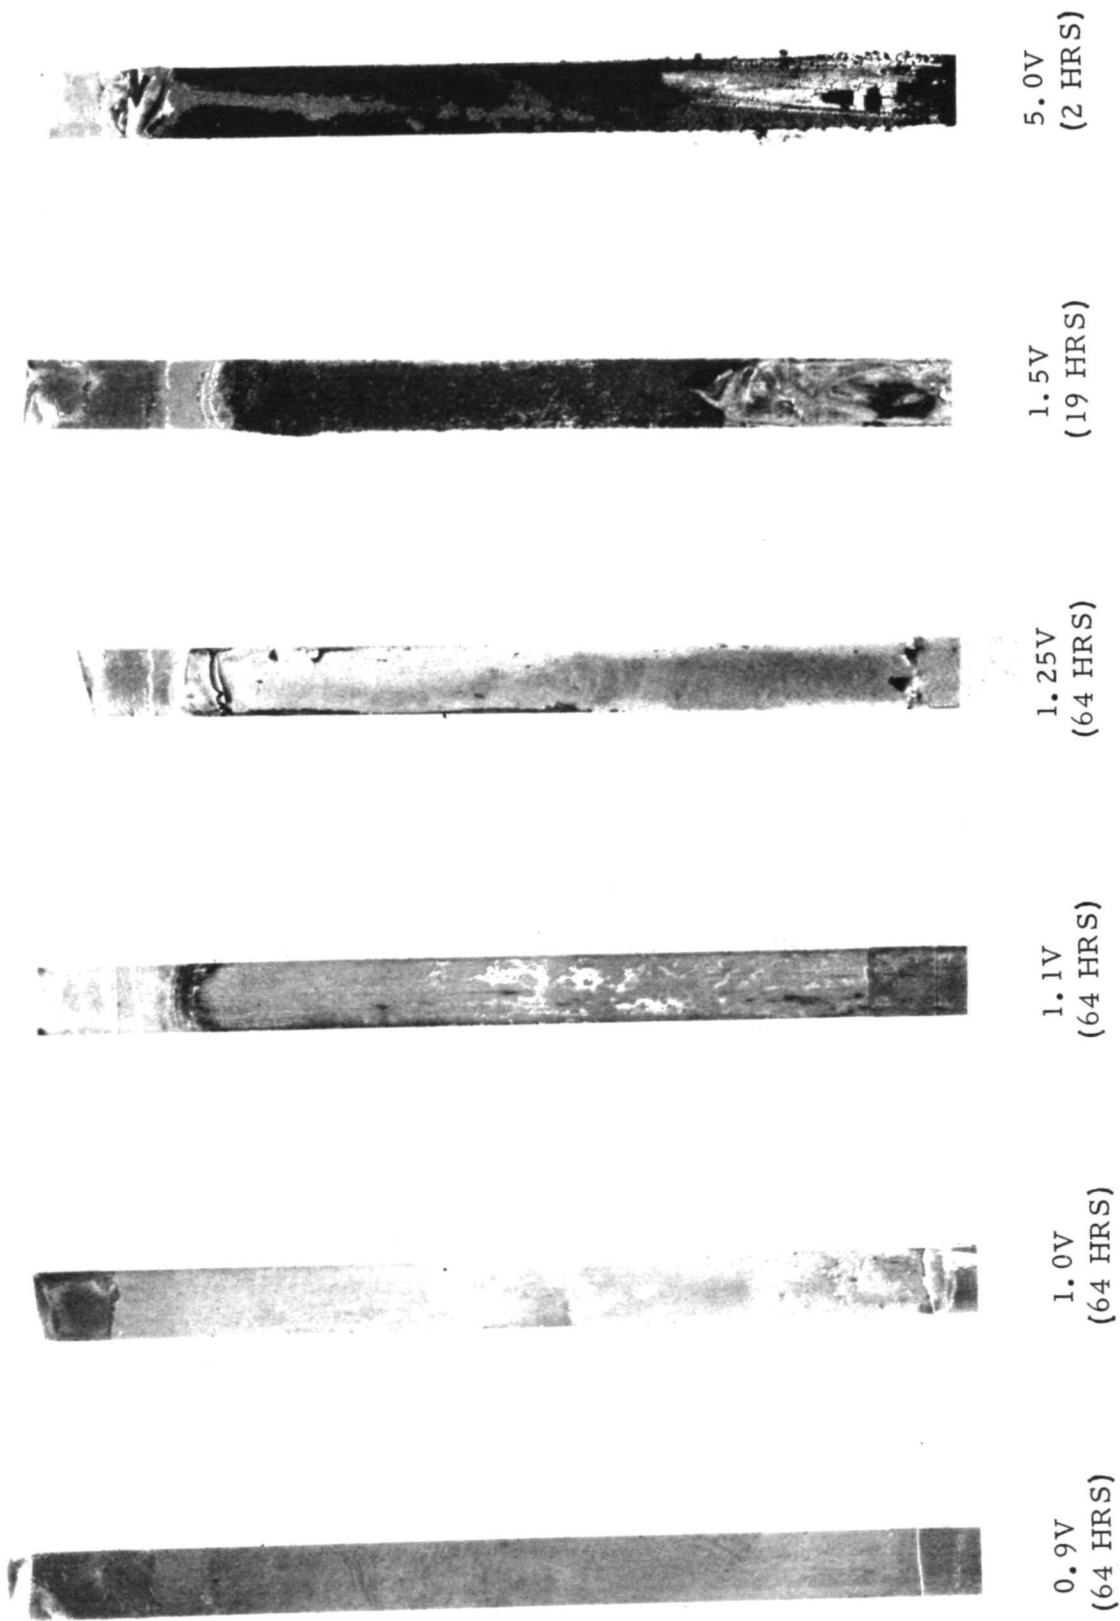
Figure 15. Cathode Deposition As A Function Of Cell Voltage

more rapid and at 5 vdc the cell circuit is opened from complete dissolution of the anode in two hours. Figure 15 shows the corresponding cathodes with a progressive plating of copper from solution. There is no observable copper deposit on the cathode at the 0.9 or 1.0 vdc levels; although there is evidence of anode dissolution at these voltages.

The onset of significant electrolytic activity in the area of 1.5 volts, as shown by the condition of the electrodes (figure 14 and 15), is considered quite significant and a series of current/voltage experiments were carried out to study the observation. Current versus voltage data were collected

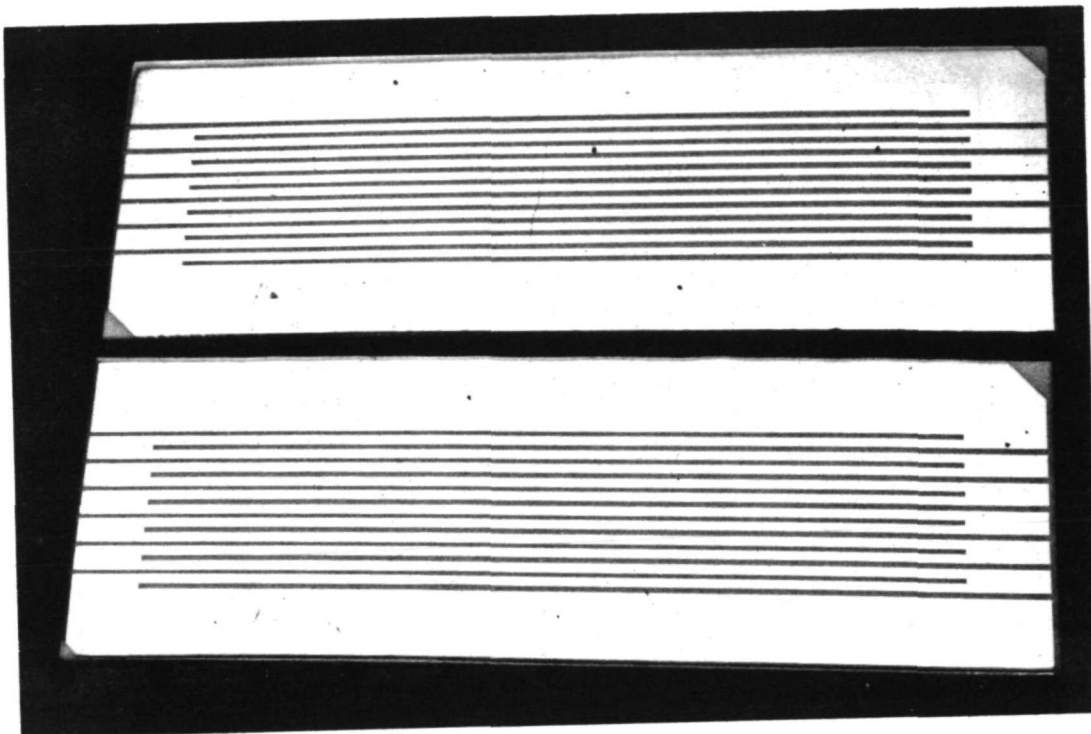
To facilitate the investigation of the failure mechanism, simulated thin film precision resistors were developed and produced in-house. These resistors were made by vapor depositing NiCr (Nichrome V) films onto Pyrex or ceramic substrates, using a precision mask to provide the necessary conductive path length and spacing. Details of the process are given in Appendix I. Photographs of the two types of resistors used are shown in figure 38.

Figure 38. Vapor Deposited Thin Film Resistors

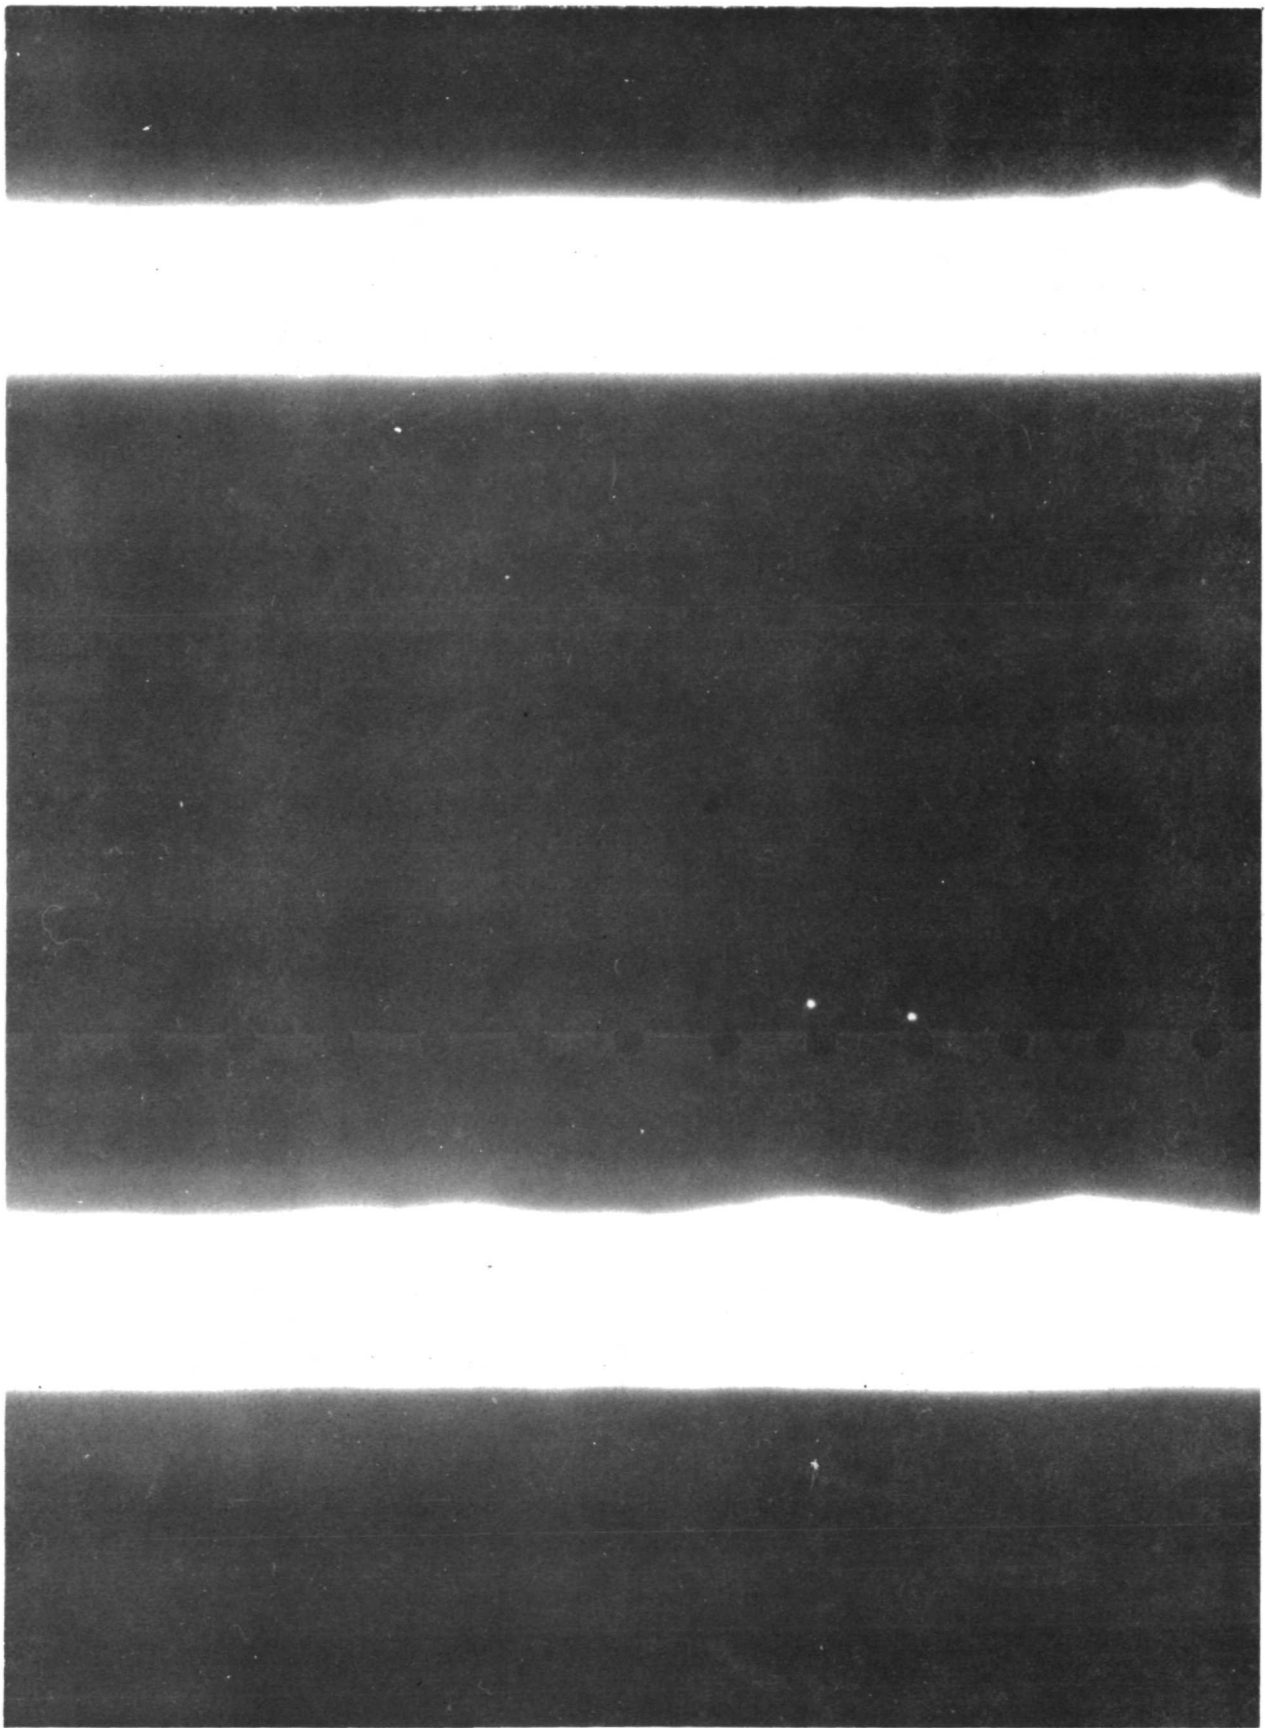
1. Liquid Electrolyte Tests. The first series of tests with the simulated resistors were simply an attempt to duplicate the damage mechanism observed in the drifting Vamistors. A slide was setup in the microscope, a drop of one percent plating solution was applied to the surface, and a potential of 10 vdc was applied. The NiCr film began eroding immediately from the anode and bubbles were observed forming at the more negative strip. The observed pattern of erosion was almost identical to that observed with the Vamistors. When the polarity of the applied dc voltage was reversed, the reaction observed was identical to the previous test, except that both the direction of erosion and the consequent damage pattern was reversed.

leads. The voltage was applied for 2 minutes, then reversed, and continued for 2 minutes. Damage occurred to both films with an almost identical erosion pattern, except that the conductive film edge which was attacked last was slightly smaller due to the increased gap. Photographs of these three runs are shown in figures 39, 40, and 41.

Figure 39. Liquid Plating Solution and dc

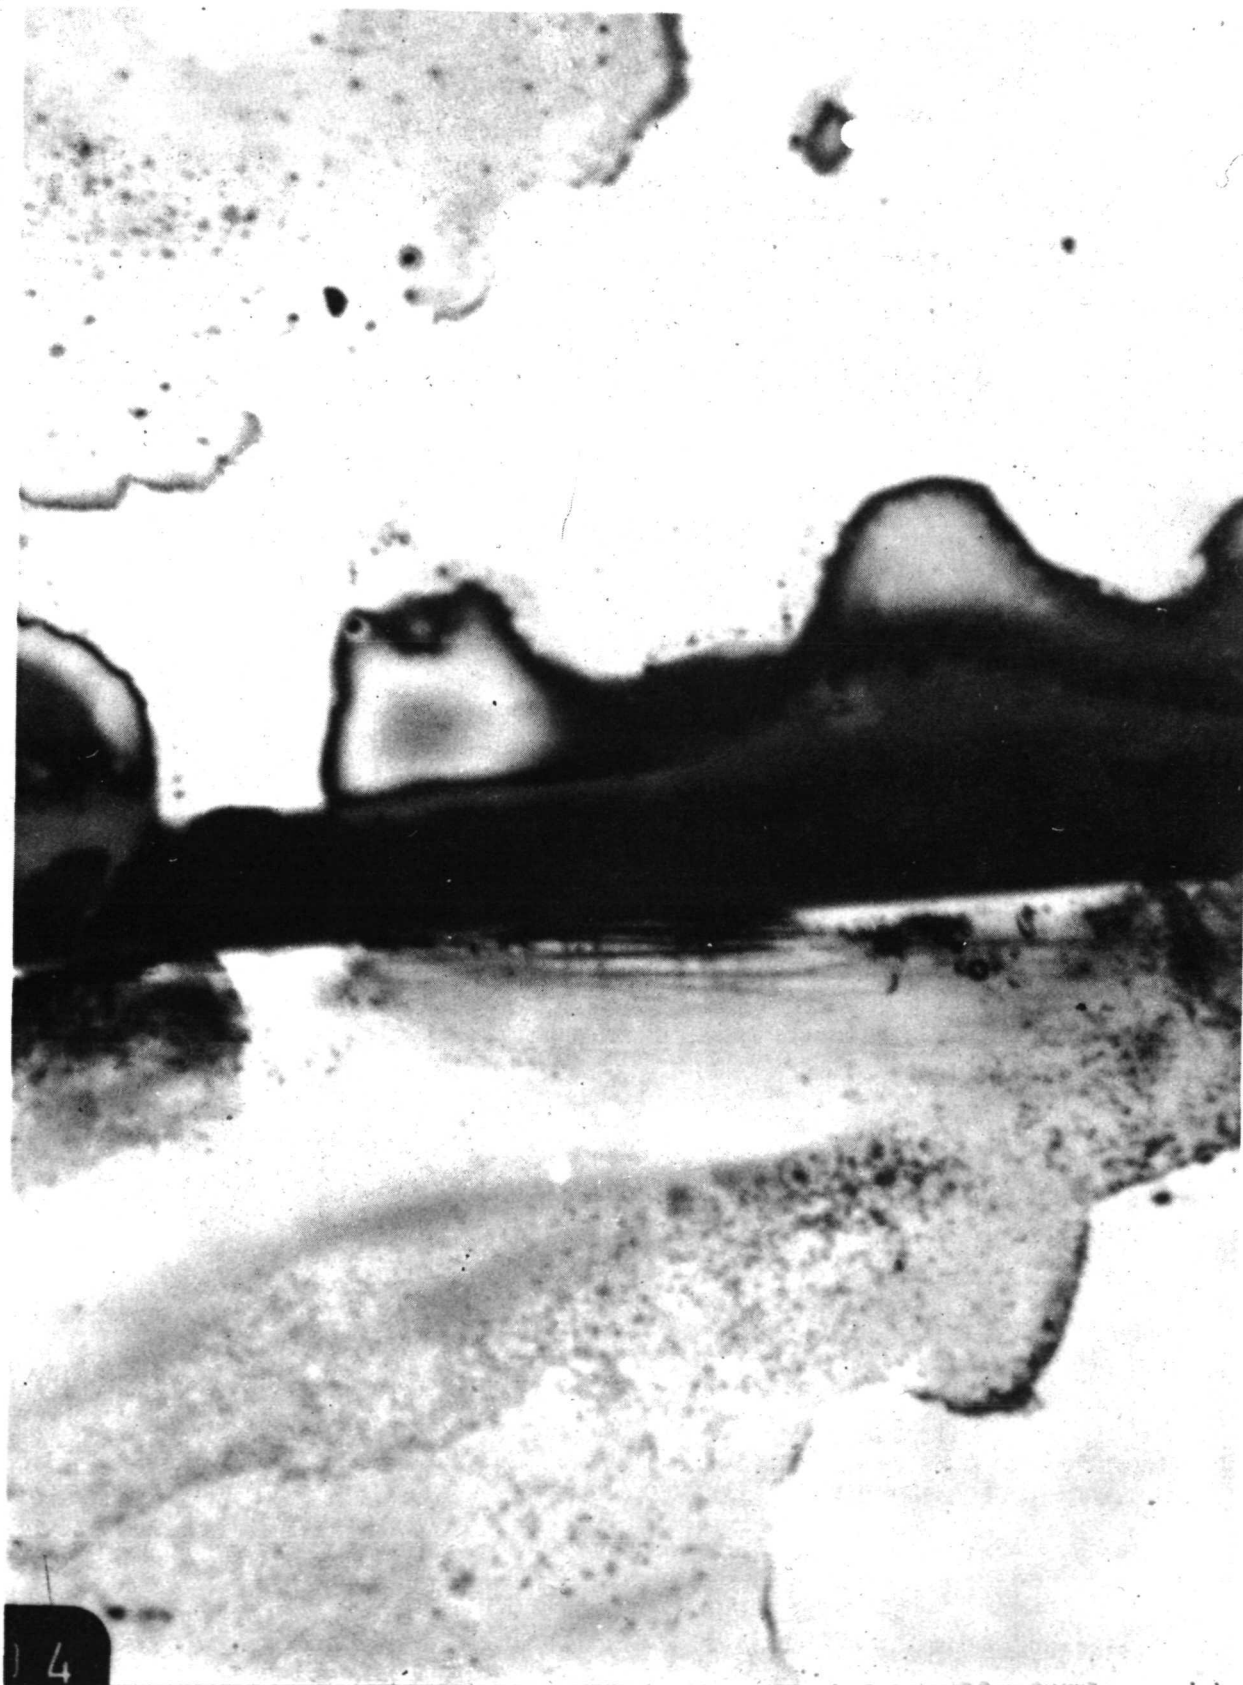
Figure 40. Liquid Plating Solution dc, and dc Polarity Reversed

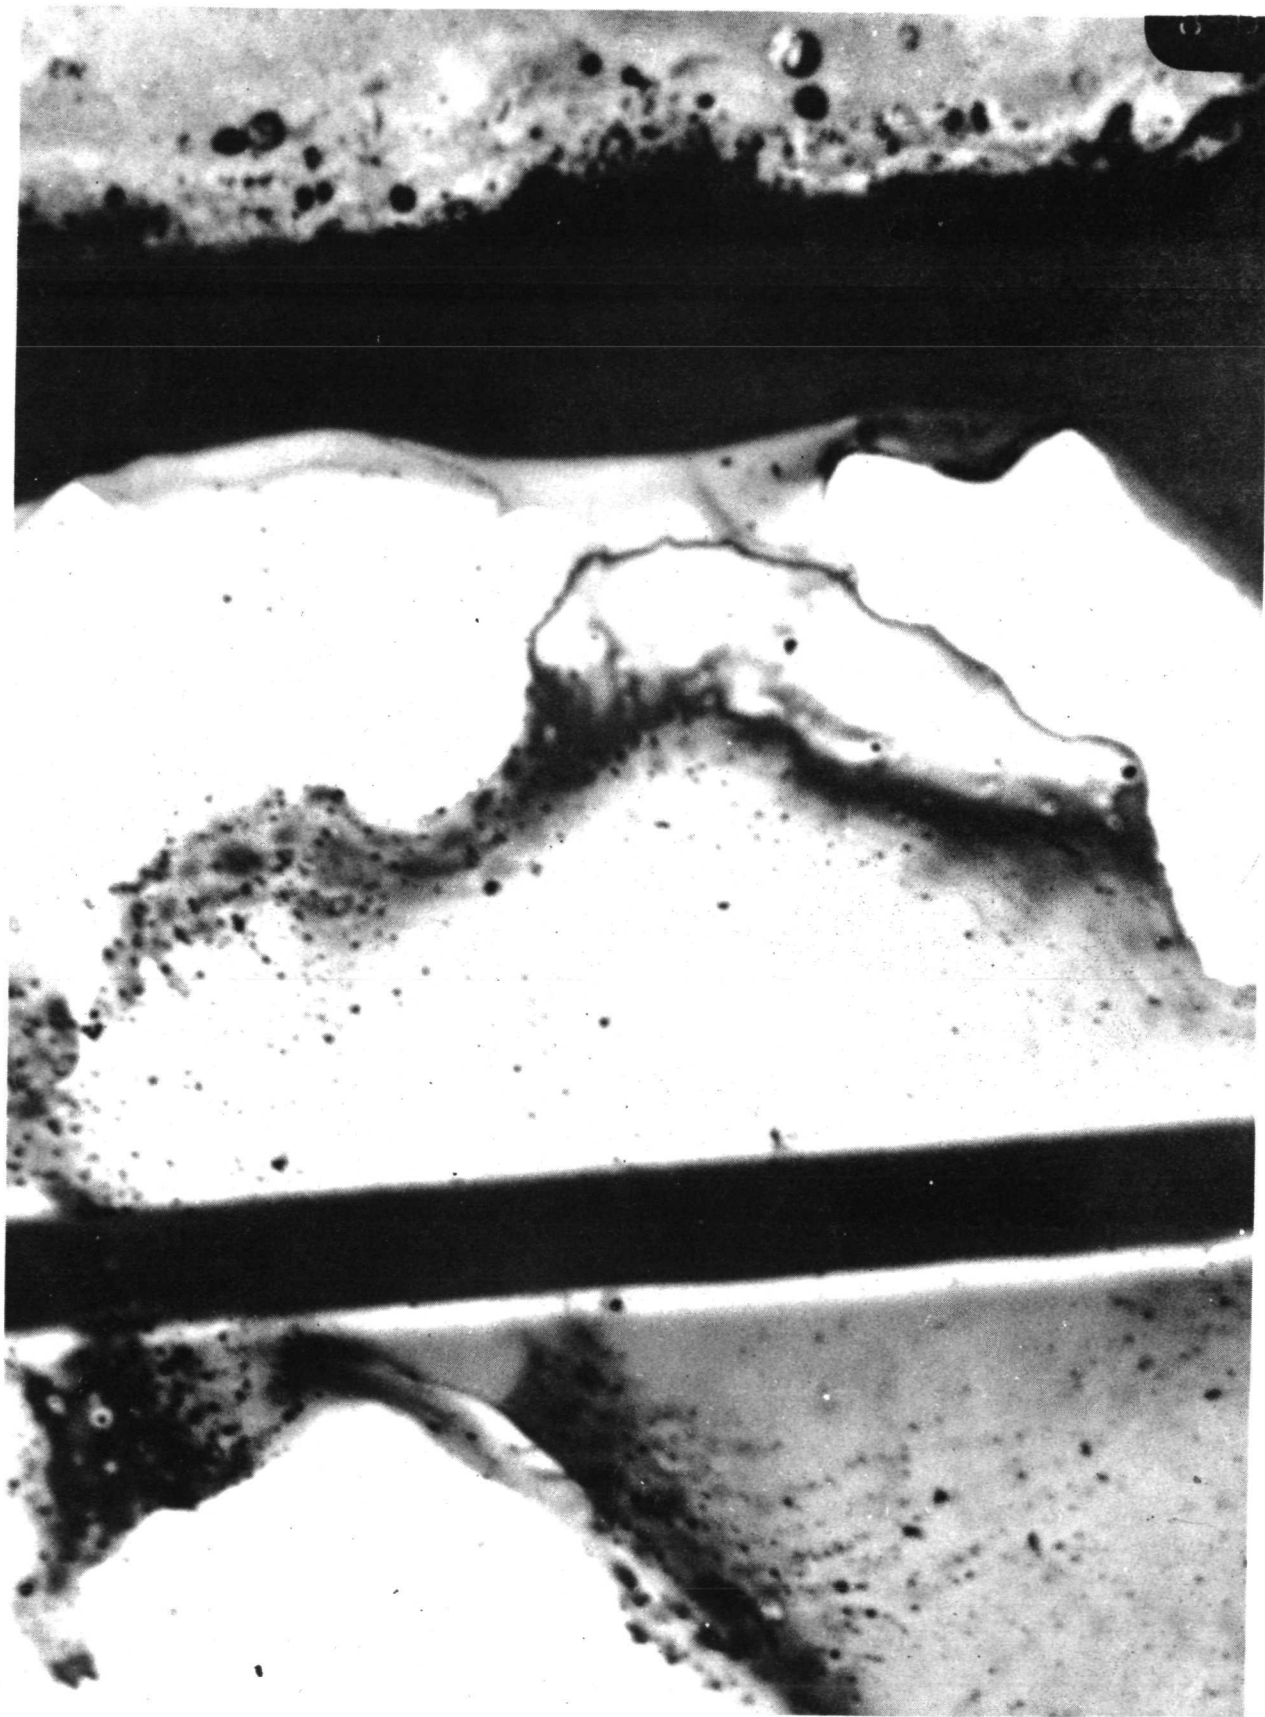
A third test was conducted in this series, using the same basic setup, but with a switch added to allow polarity reversal without removing

Figure 41. Liquid Plating Solution dc for 2 Minutes, reversed
Polarity for 2 Minutes

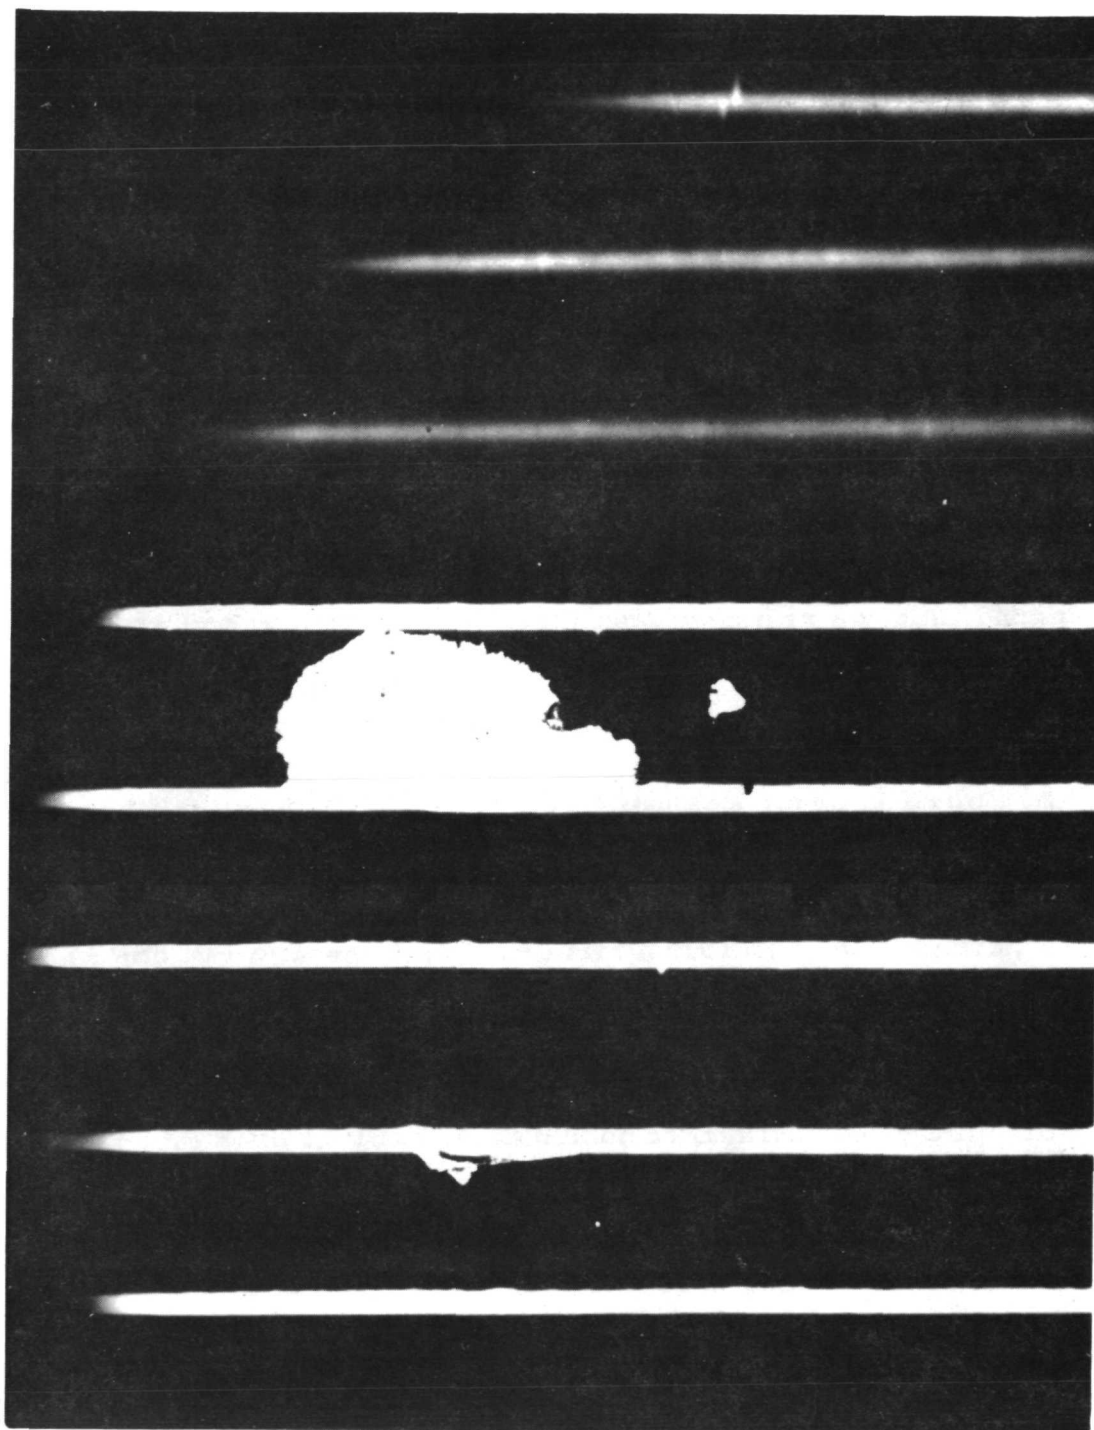
Figures 42, 43, and 44 show photographs of damage resulting from voltage types a, b, and c, respectively.

Figure 42. Dried Electrolyte, Water Vapor, and dc

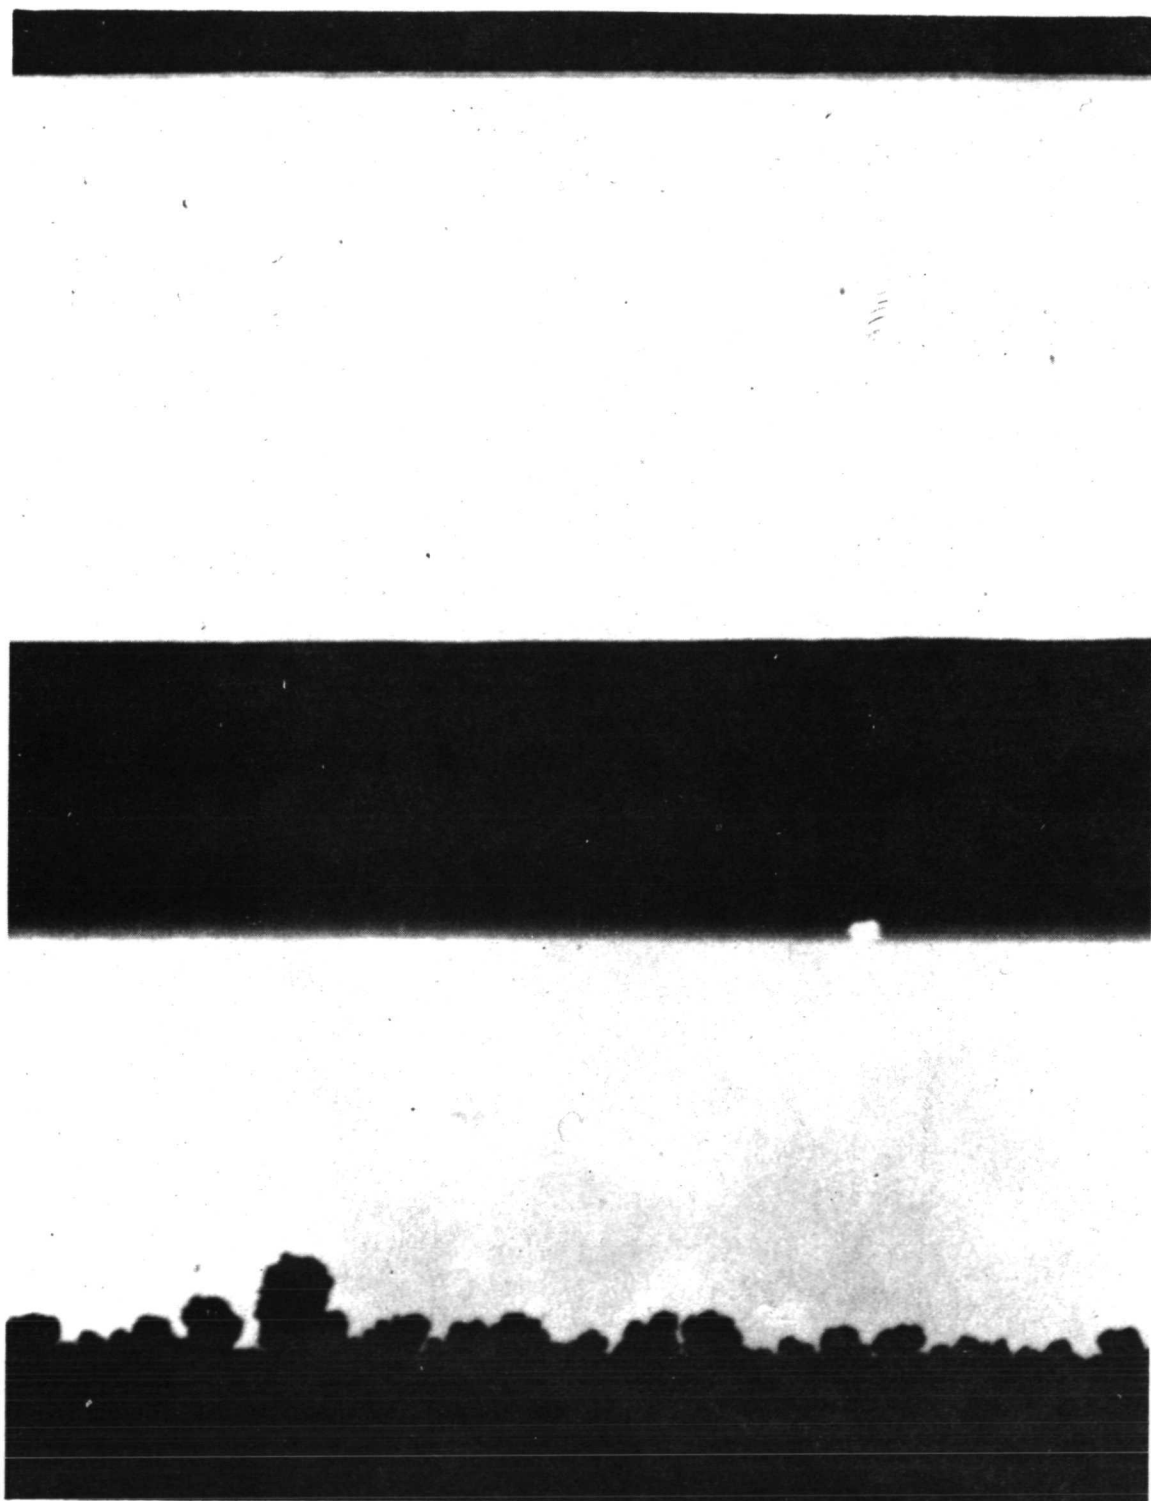
Figure 43. Dried Electrolyte, Water Vapor, and Pulsating dc

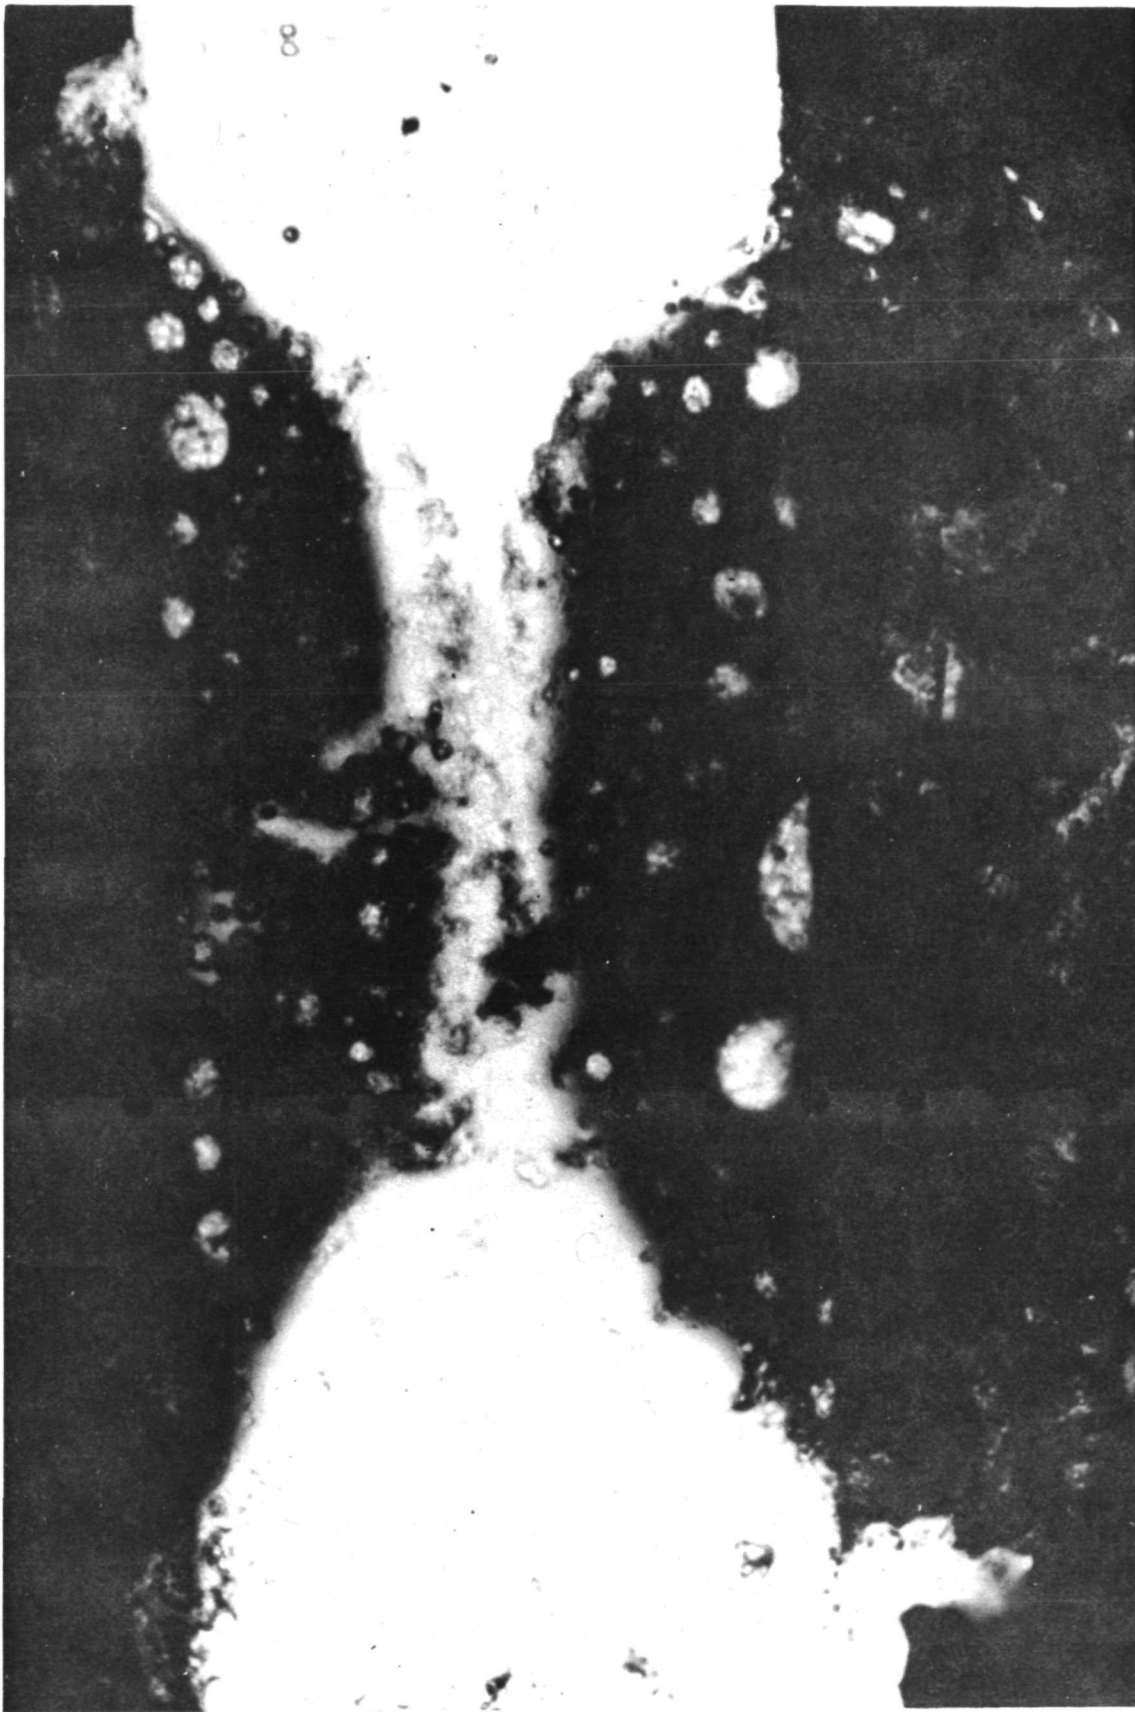
Figure 44. Dried Electrolyte, Water Vapor, and
60 Hz ac

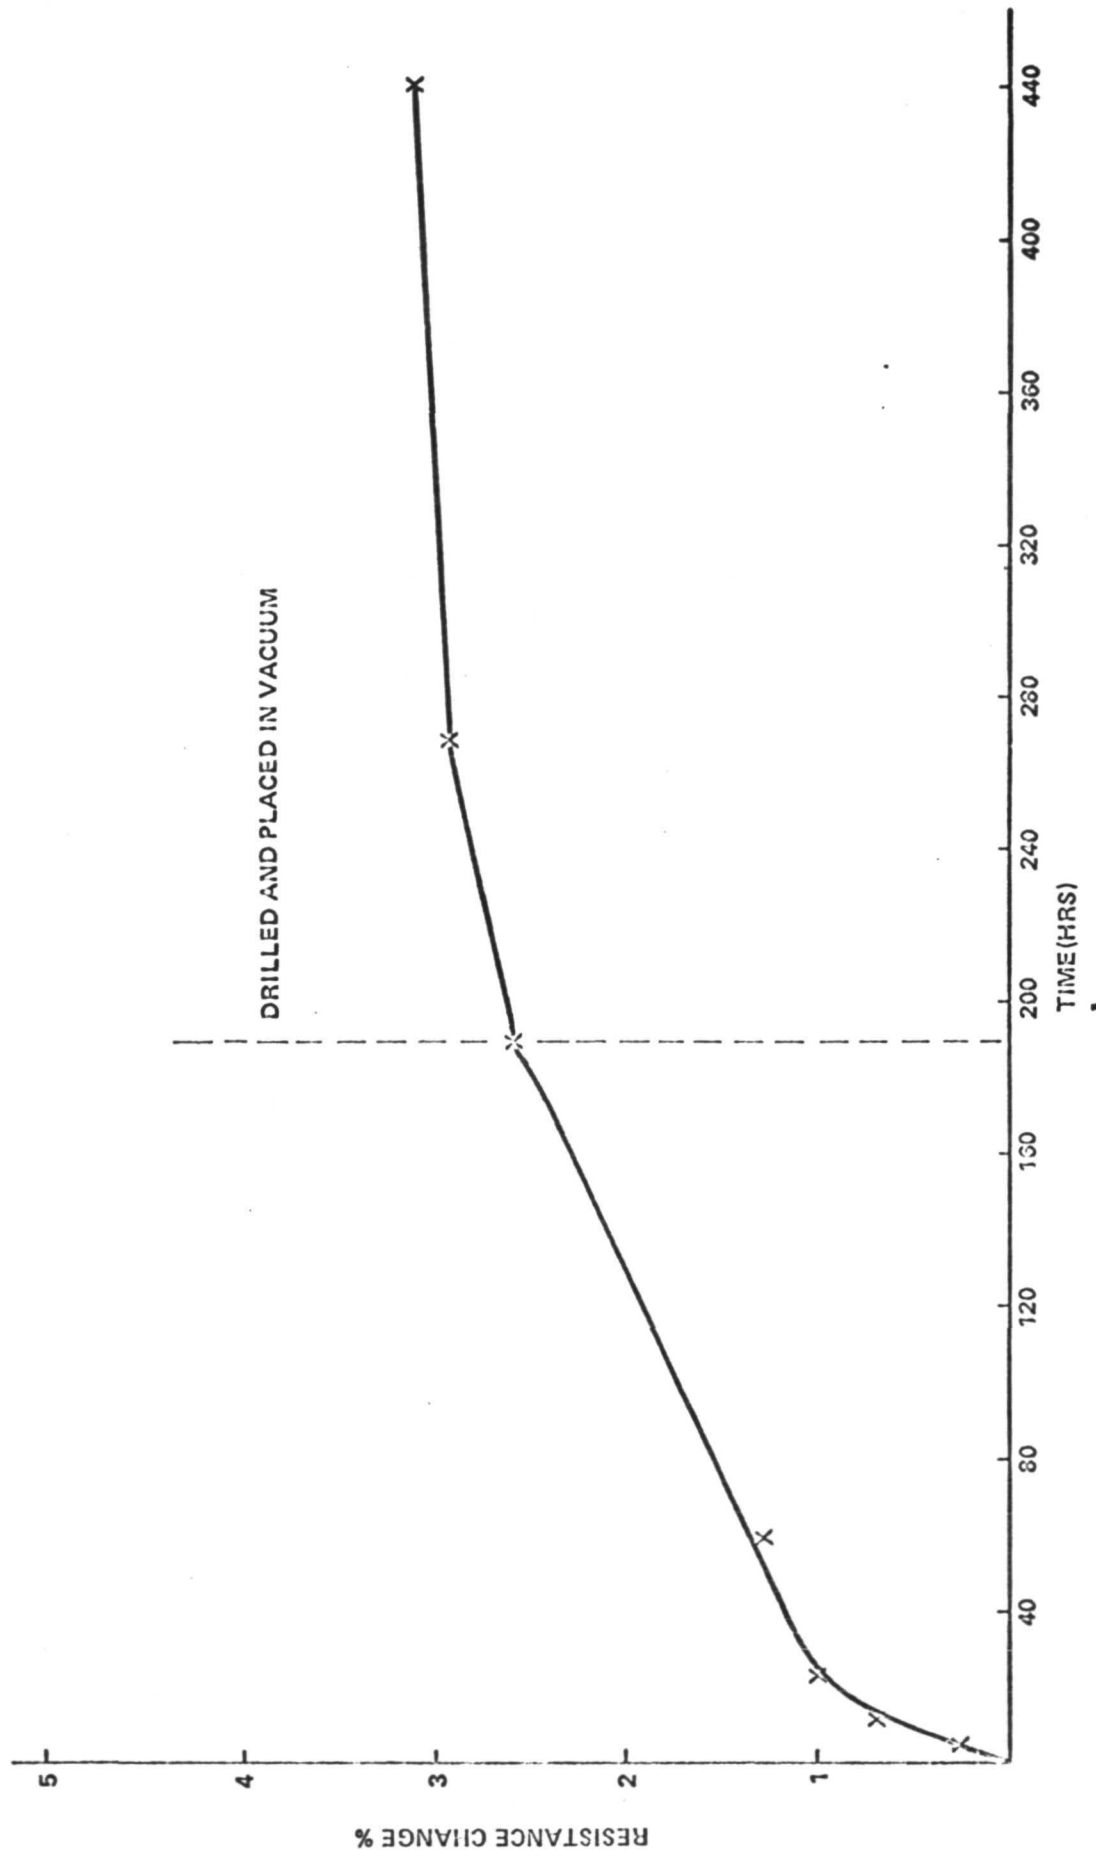
a. Test #1. The first test was on a single resistor ($5\text{ K } \Omega$) whose resistance had been changing consistently. The resistance of the unit was monitored for 190 hours. At this point, a 0.030-inch hole was drilled in one endcap, and the resistor was placed in a vacuum chamber which was then evacuated. A plot of resistance change as a function of time is shown in figure 45. The resistor changed by 2.6 percent in 190 hours when sealed and only 0.4 percent after 250 hours of vacuum exposure.

Figure 45. Effect of Removing Humidity From Drifting Resistor - 5K Resistor At 2 Volts

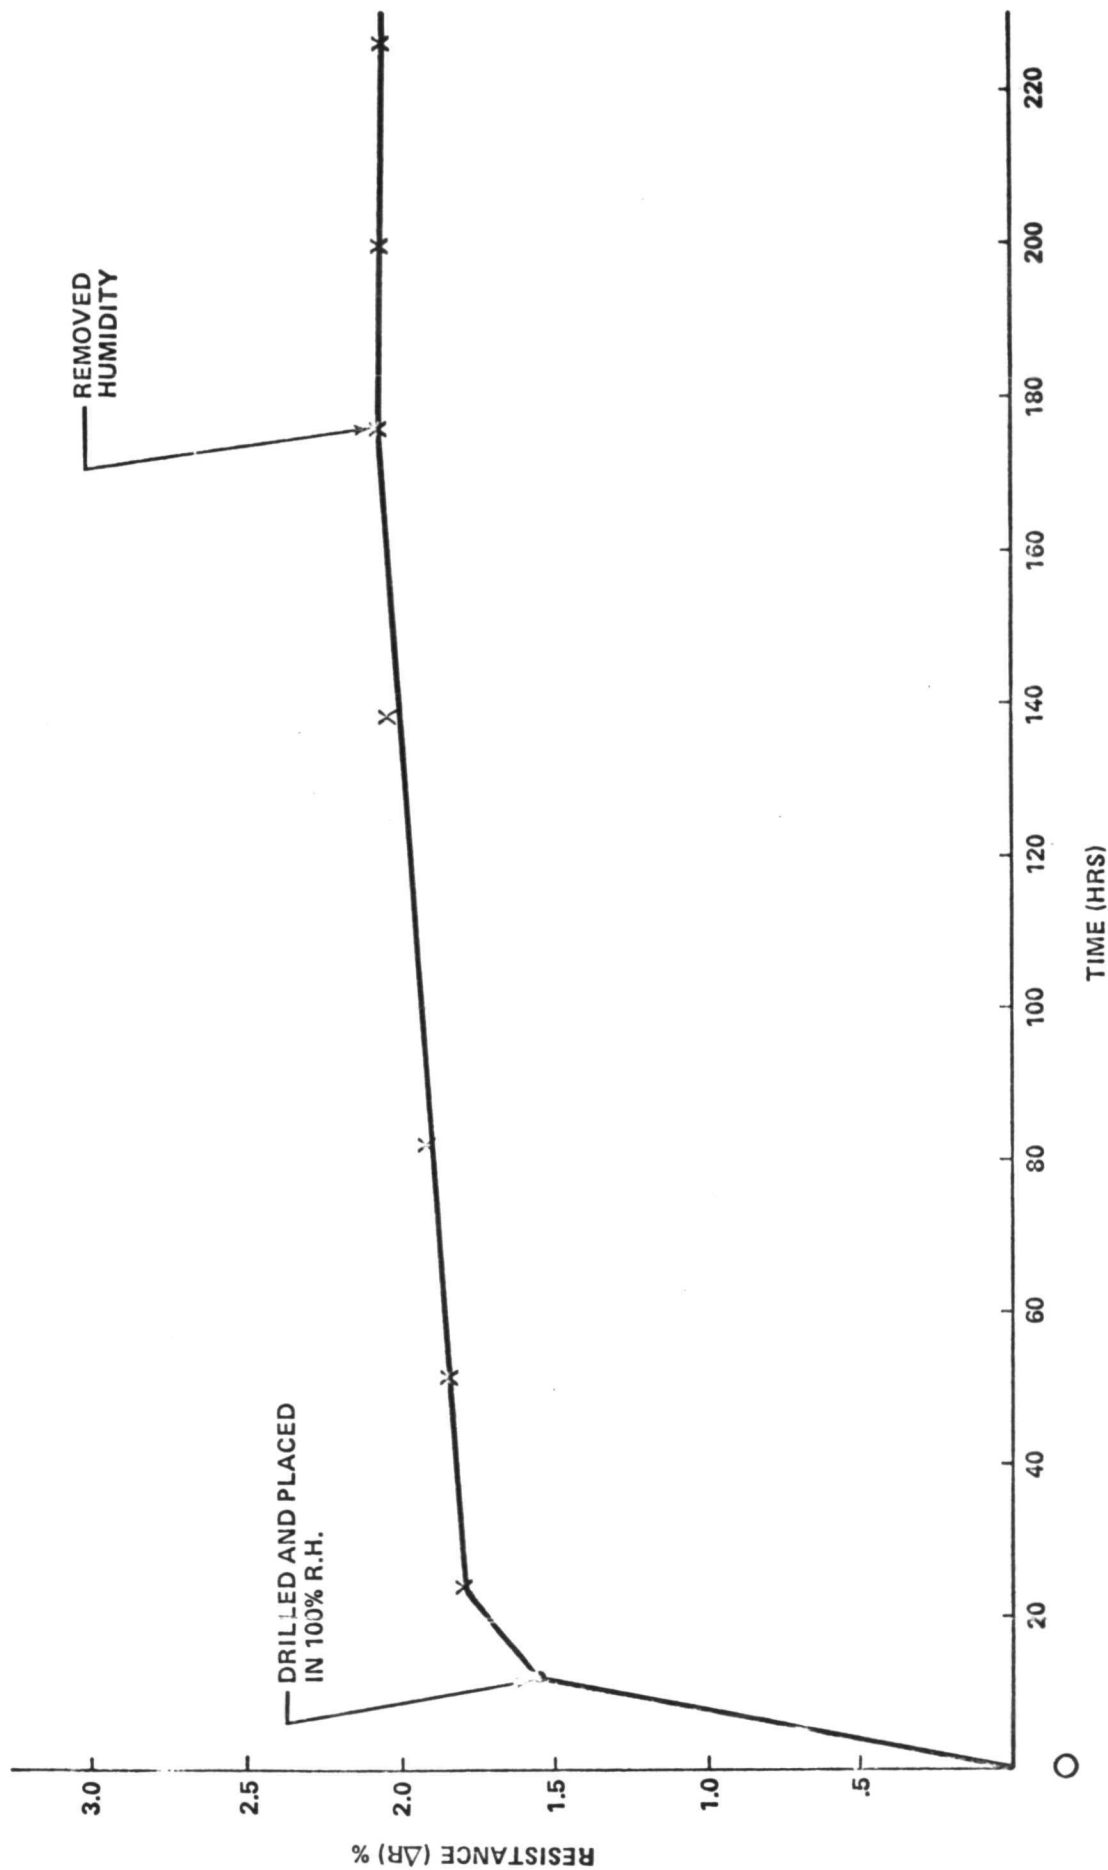
b. Test #2. For this test, three resistors with a known history of drifting were selected. The resistors had a 0.030-inch hole drilled in each endcap and they were placed in a test chamber with 100 percent relative humidity. With voltage applied, the resistors drifted 0.6, 0.25 and 0.1 percent over 160 hours. At this point, the water vapor was pumped out of the chamber. All three resistors stopped drifting. A plot of resistance change of one of the resistors as a function of time, indicating the point at which the chamber was evacuated, is given in figure 46.

Figure 46. Humidity and Drying Test on Vamistor Resistors

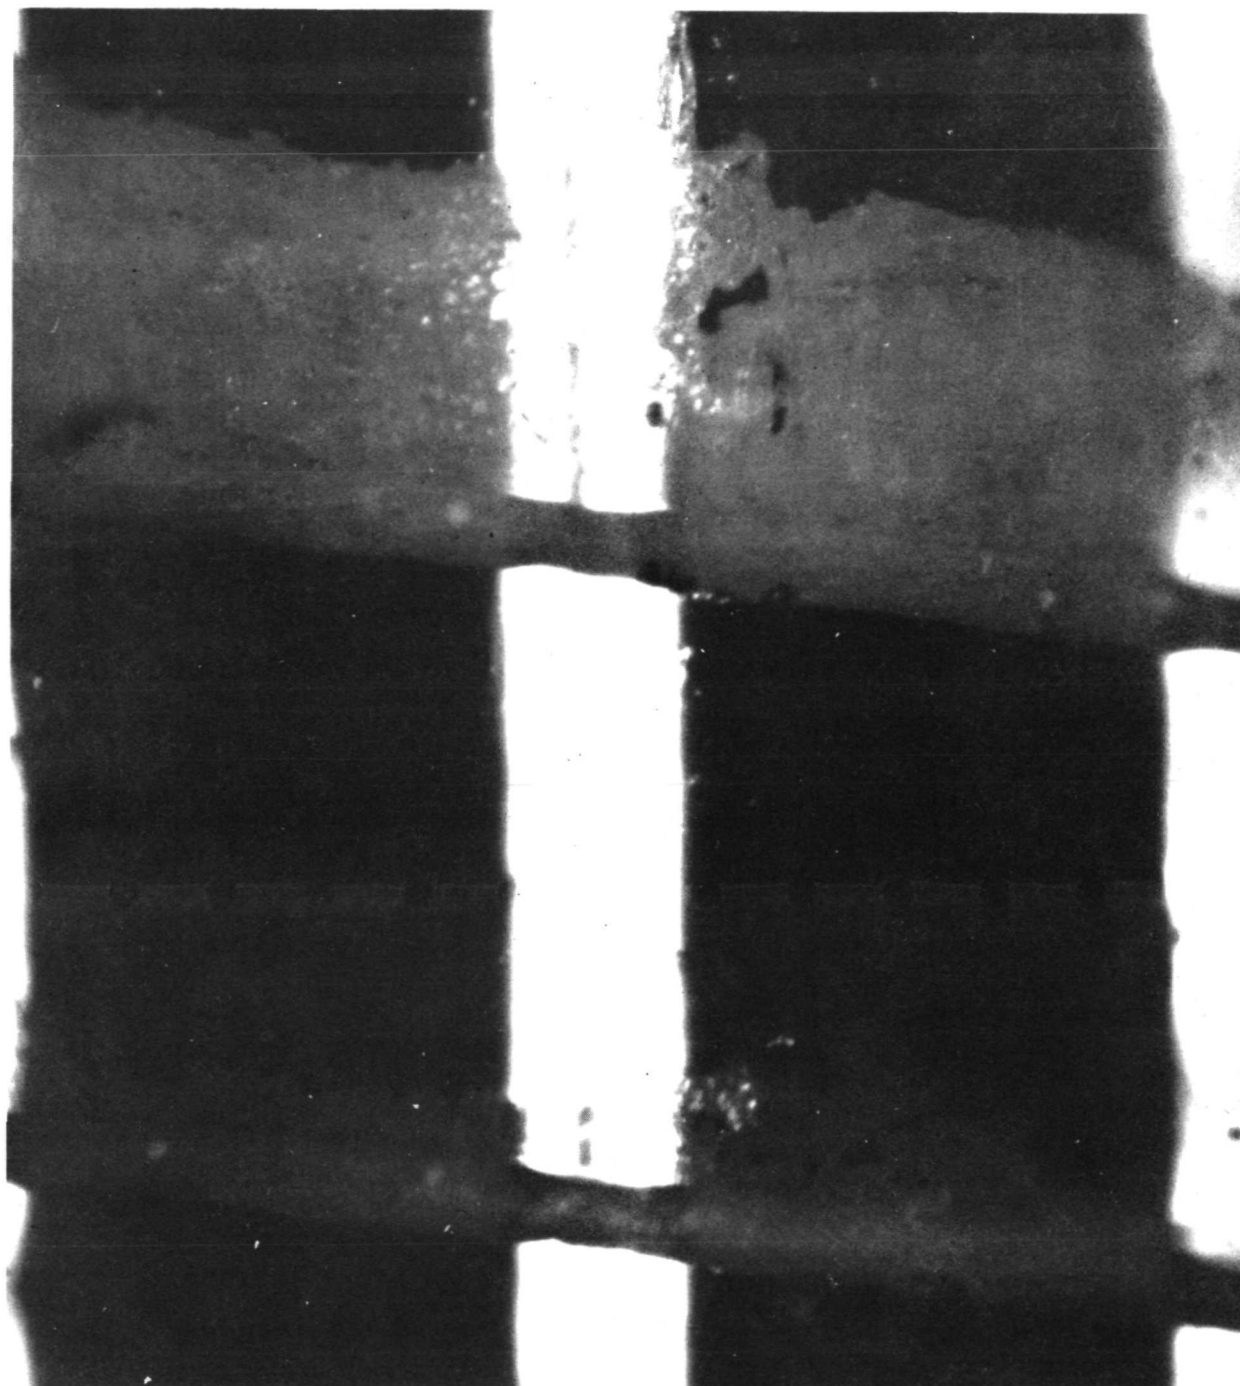
The two resistors that were removed were sectioned and examined. Both exhibited the characteristic damage mechanism of Vamistor resistors that had drifted. Photomicrographs of these two resistors are shown in figures 51 and 52.

Figure 51. Resistor R22, Dried Plating Solution in 100% Relative Humidity At 22% VR For 8 Hours (100% Change)

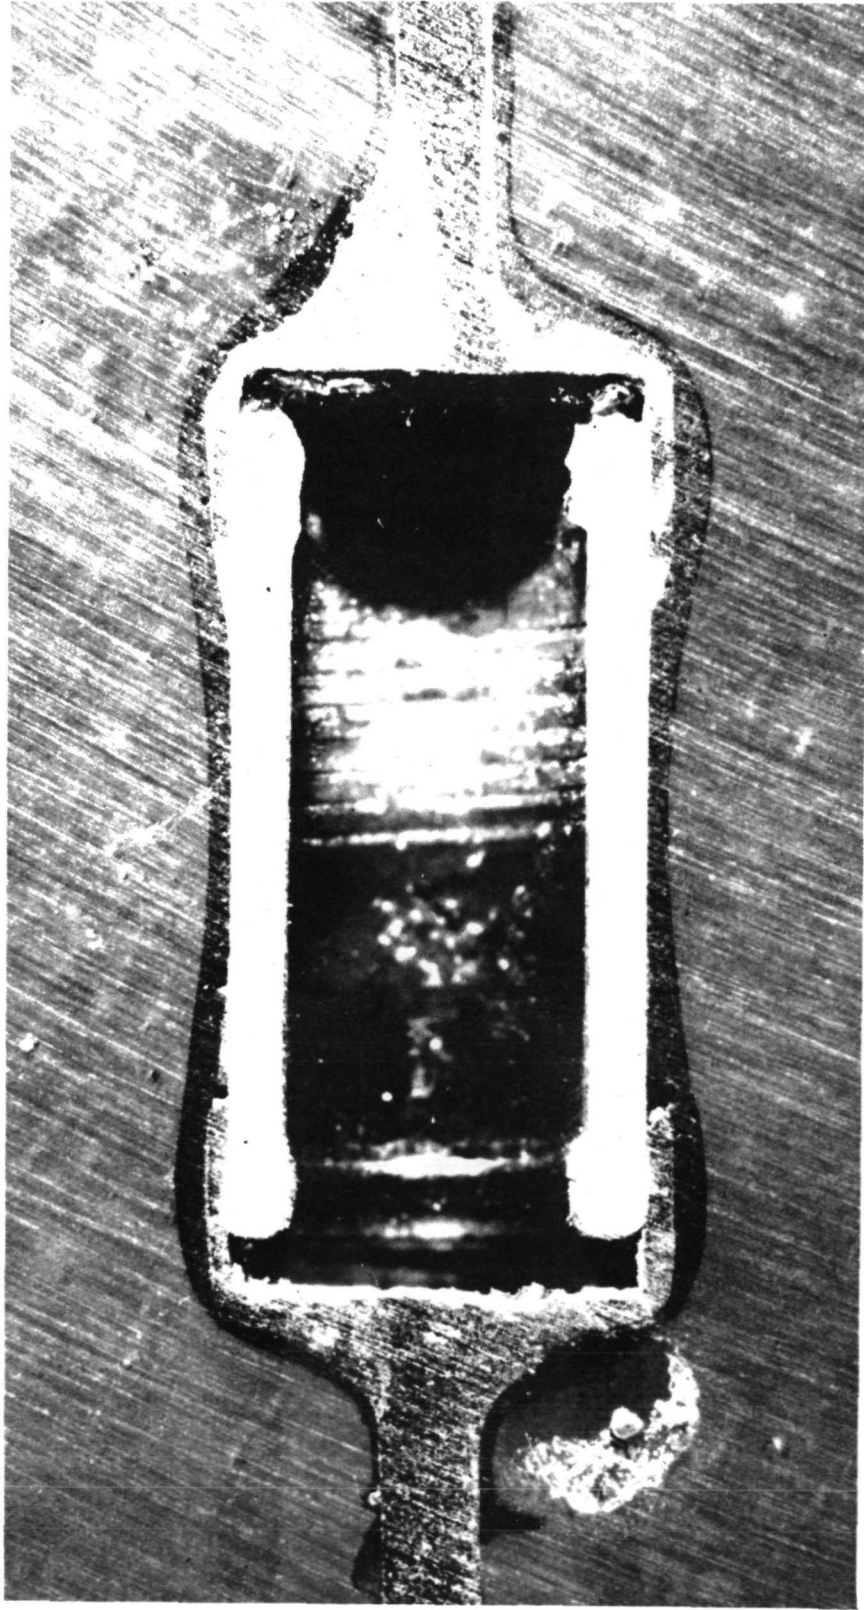
Figure 52. Resistor R28, Dried Plating Solution in 100% Relative Humidity At 22% VR For 138 Hours (20% Change)
